RESERVOIRS

FOR IRRIGATION, WATER-POWER

DOMESTIC WATER-SUPPLY

WITH AN ACCOUNT OF VARIOUS TYPES OF DAMS AND THE
METHODS, PLANS AND COST OF THEIR CONSTRUCTION

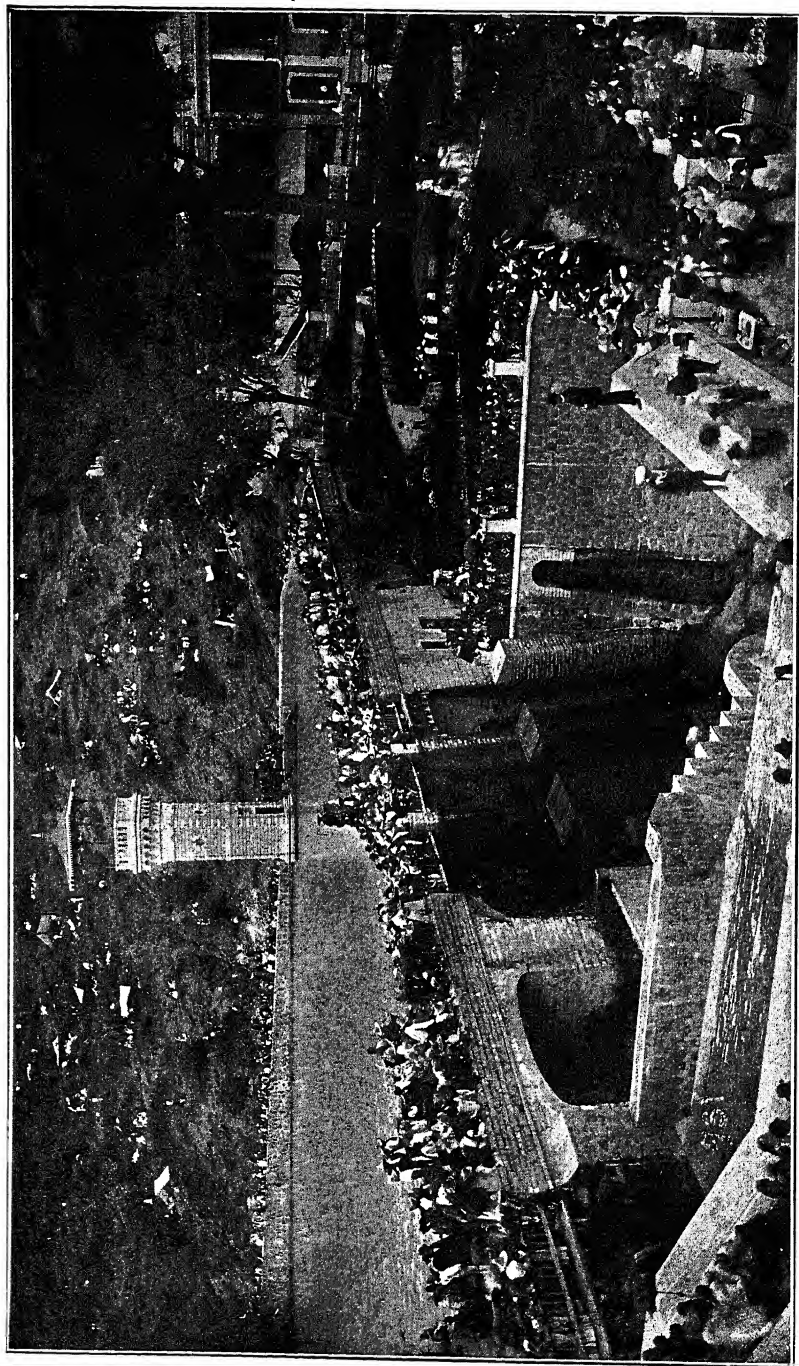
FIG. 255.—LOWER DAM, OR "PRESA DE LA OLLA," GUANAJUATO, MEXICO. VIEW TAKEN DURING THE FEAST DAY WHEN THE GATES ARE RAISED AND THE RESERVOIR EMPTIED.

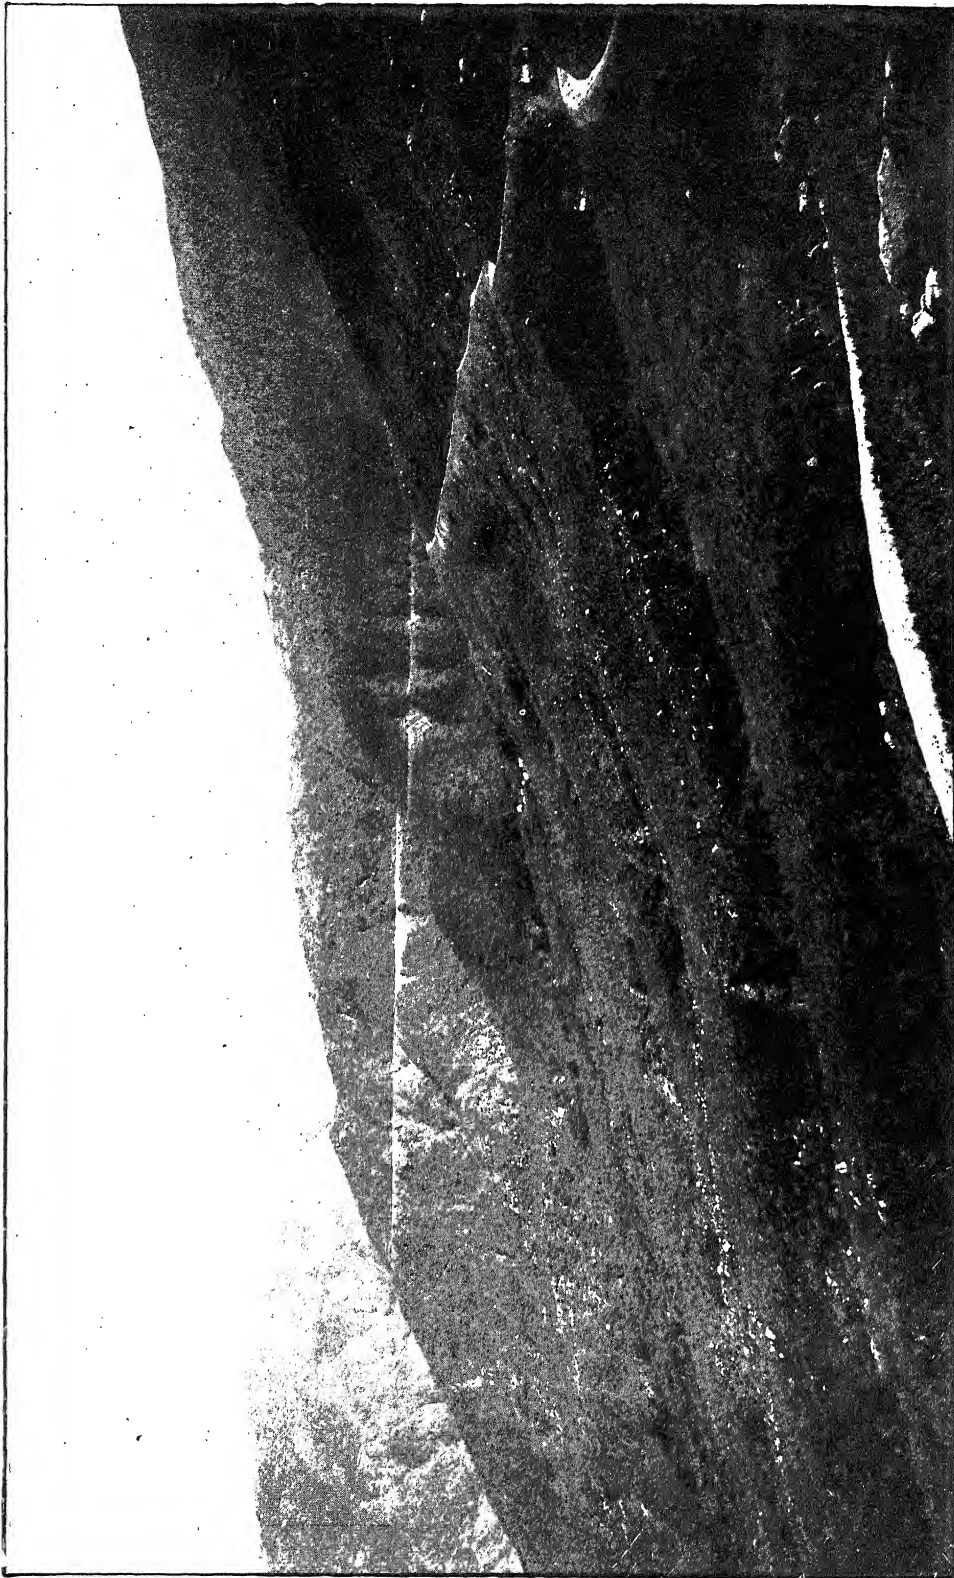
FIG. 2.—FEEDER CANAL ON THE SIDE OF RODRIGUEZ MOUNTAIN, ESCONDIDO IRRIGATION DISTRICT.

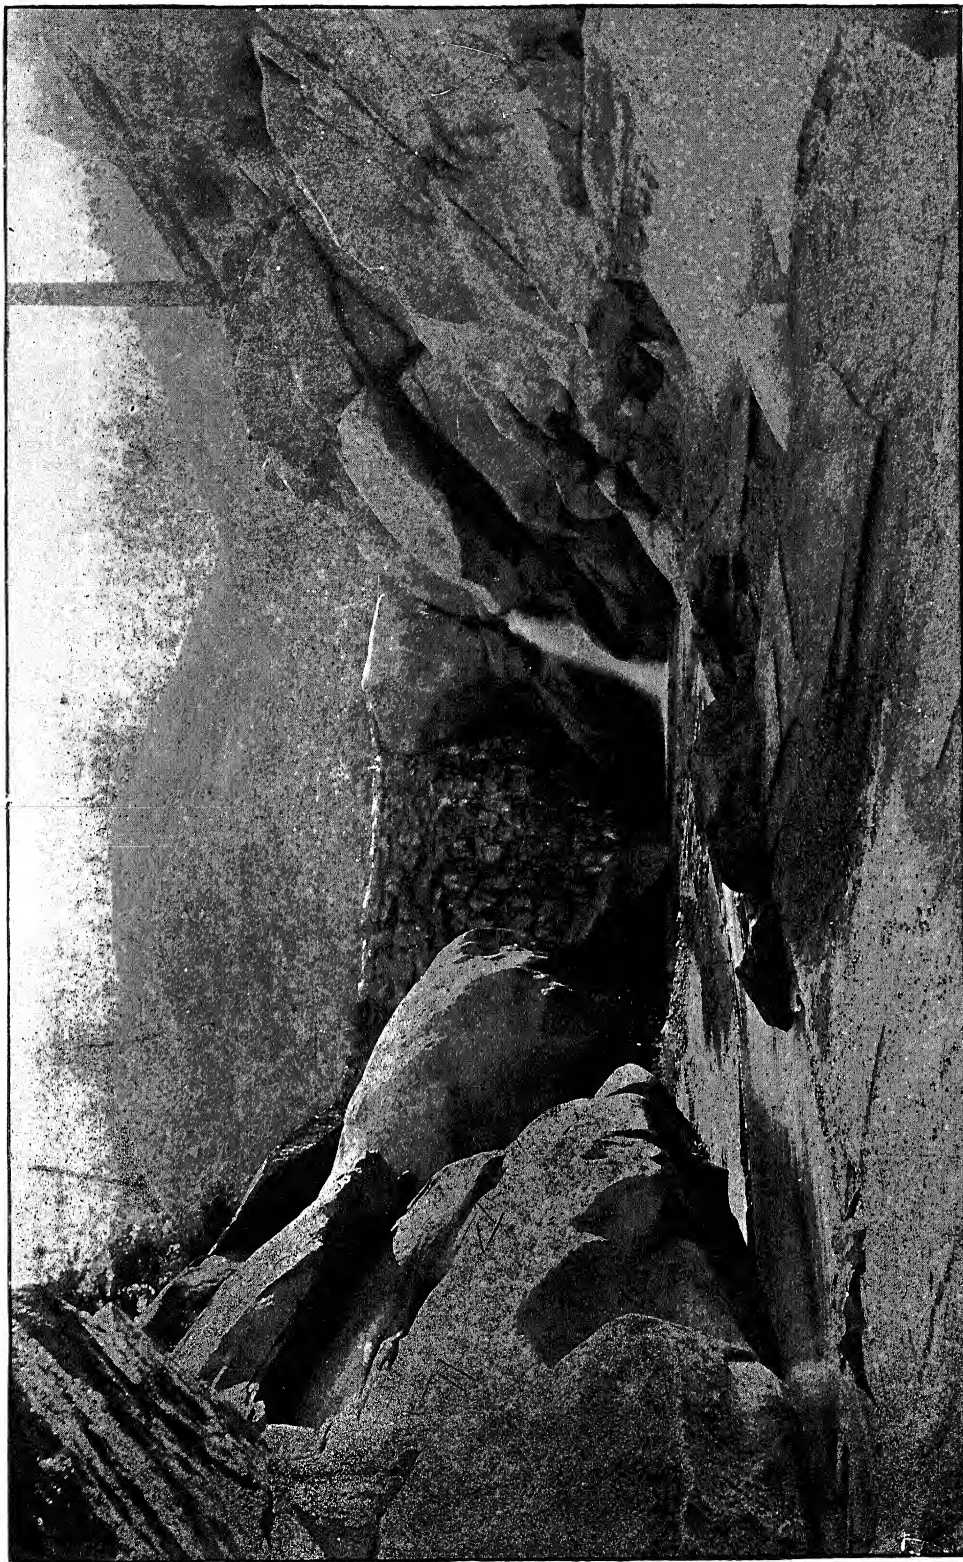
FIG. 20.—THE BARRETT DAM-SITE, SHOWING THE BEGINNING OF MASONRY FOUNDATIONS.
The material on left bank above the rock here shown is disintegrated granite to such depth as to require change of plans from original design.

In 1897 the company erected a masonry dam, shown in Fig. 20, 72 feet in height from its base, which is 22 feet below the stream-bed, to its top 50 feet above. This structure rests on solid granite bed-rock throughout, and is 14 feet thick at bottom, 5 feet at top, and about 30 feet long on the crest. This was to be used simply as a pick-up weir to divert water into the Dulzura pass conduit. Subsequently it was decided to build a storage dam, similar in plan to that of the Lower Otay, to an extreme height of 175 feet, and a new location was chosen about 1000 feet further down stream, where rock could be more conveniently obtained for a rock-fill structure. Here a new masonry dam was built in 1898, reaching to bed-rock in the stream-bed and extending about 35 feet above, upon which to begin the sheet-steel core of the rock-fill. The dimensions were as follows:

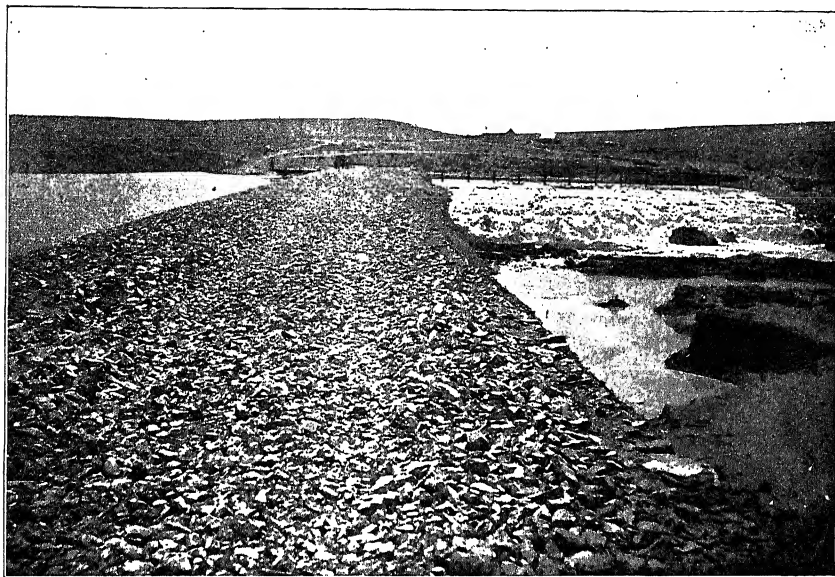
FIG. 34.—LAKE AVALON DAM, PECOS RIVER, NEW MEXICO. SHOWING THE CREST OF COMPLETED DAM AND SPILLWAY DISCHARGING.

fill before the addition of the earth facing is illustrated by Fig. 33, a view taken during construction. Fig. 34 is a view of the finished dam, taken in 1892. The grade of the main canal leading out from the dam on the east side of the valley is 10 feet above the base of the dam, and is excavated in limestone to a maximum depth of 38 feet. Fig. 35 is a view of the main canal and headgates, taken from the lower side.

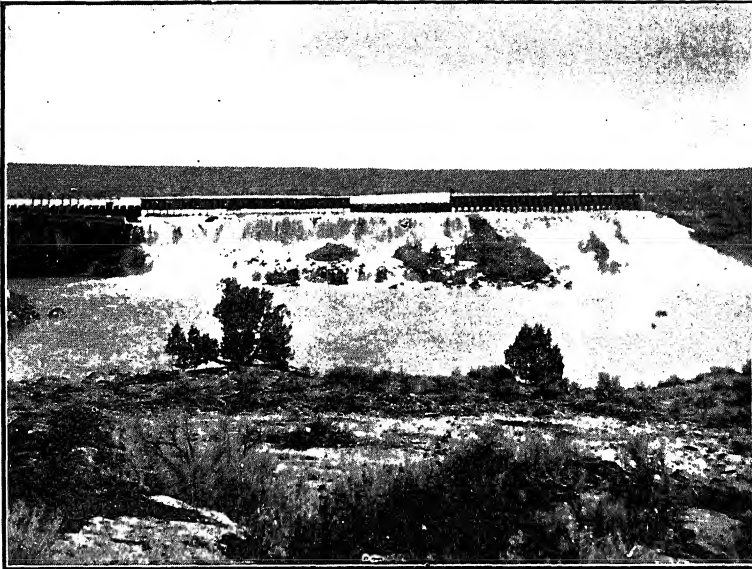
FIG. 47.—MILNER DAM, SNAKE RIVER, IDAHO. DISCHARGE THROUGH THE GREAT BATTERY OF 99 WASTE-GATES FORMING "IRRIGATION FALLS," 40 FEET HIGH.

Figs. 47, 48, 49, 50, 51, and 52 illustrate the construction of these notable dams, and Fig. 53 shows the type of head-gates successfully

The Milner Dam, Idaho.—The photograph shown in Fig. 355 gives a more comprehensive picture of the three combination dams described on page 60 than any of the other illustrations accompanying the article (see Figs. 47 to 53), and will therefore add to the interest in these important and successful dams.

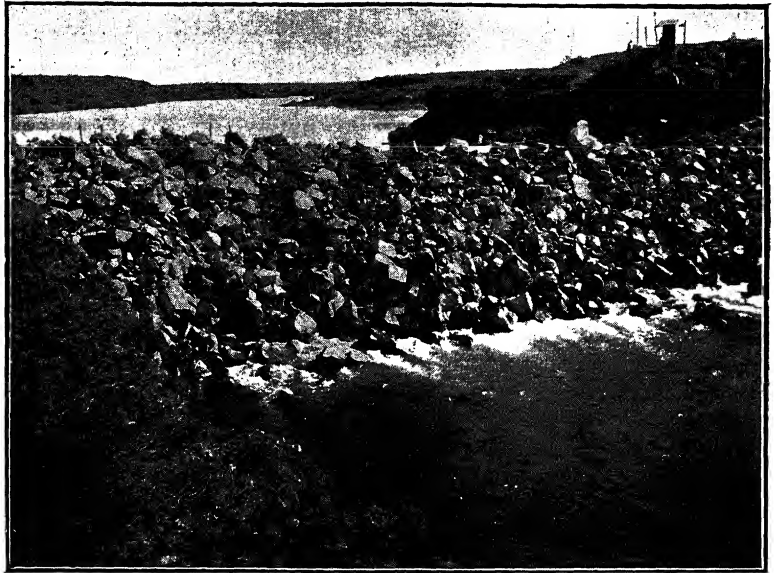
FIG. 49.—MILNER DAM, SNAKE RIVER, IDAHO. NORTH CHANNEL DAM BEFORE COMPLETION OF SHEET PILING. ABOUT 500 SECOND-FOOT IS PASSING THROUGH ROCK-FILL, UNDER HEAD OF 13 FEET.

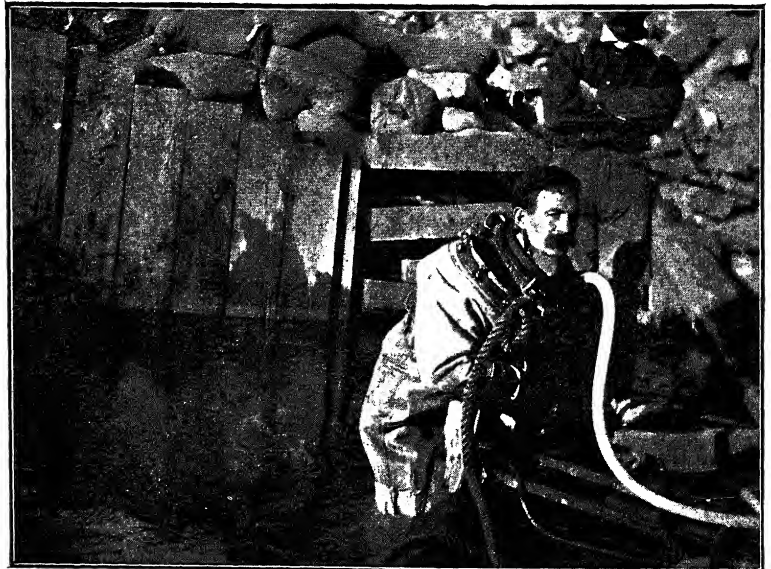
FIG. 50.—MILNER DAM. DIVERS AT WORK PLACING SHEET PILING IN 40 FEET OF WATER.

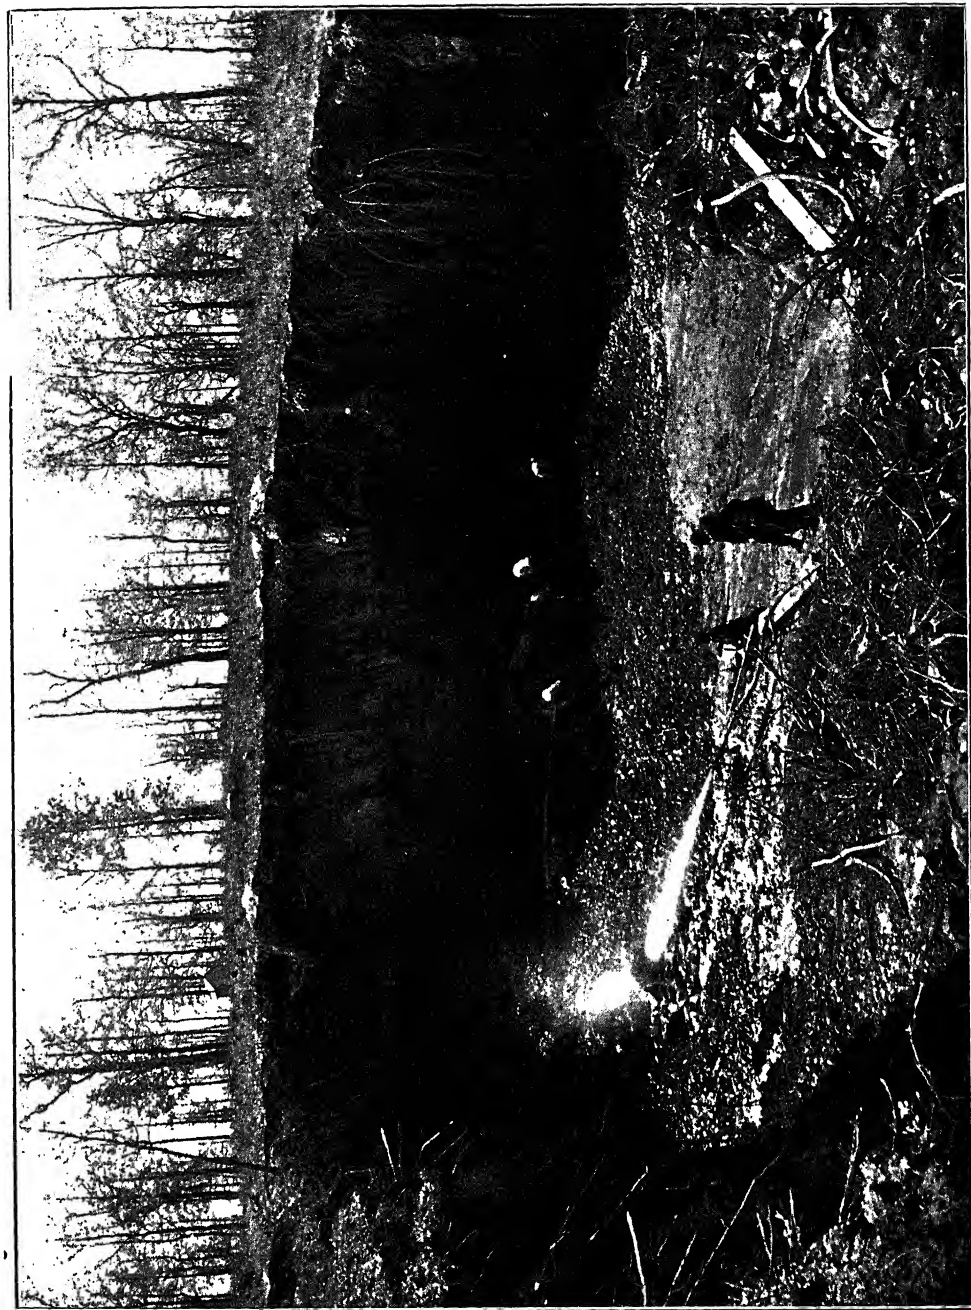
FIG. 68.—HYDRAULIC SLUICING FOR BUILDING DAM AT TYLER, TEXAS.

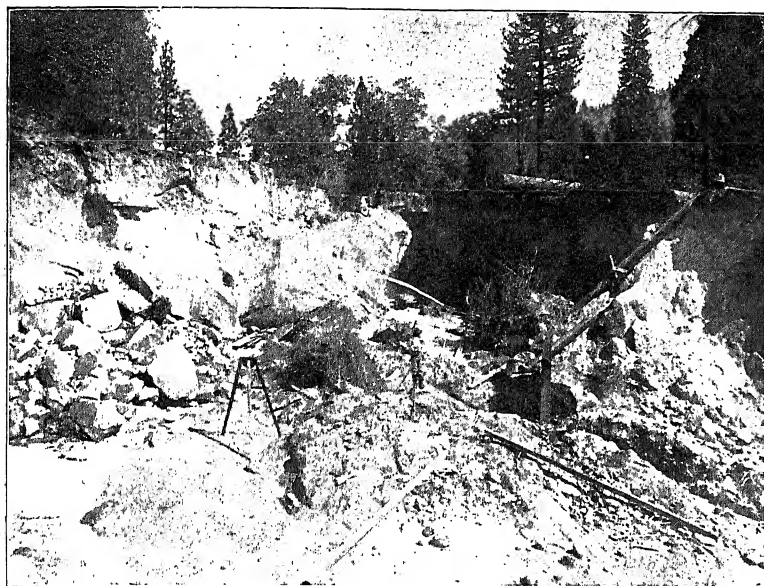
FIG. 81.—CRANE VALLEY HYDRAULIC-FILL DAM. SHOWING METHOD OF LOOSENING THE MATERIALS SLUICED INTO THE DAM.

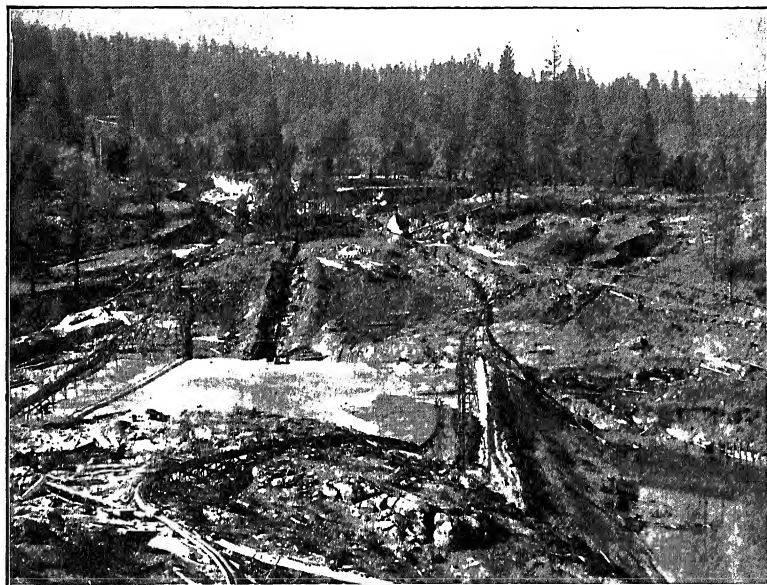
FIG. 82.—BORROW-PITS FROM WHICH MATERIAL WAS SLUICED TO THE CRANE VALLEY DAM IN BACKGROUND.

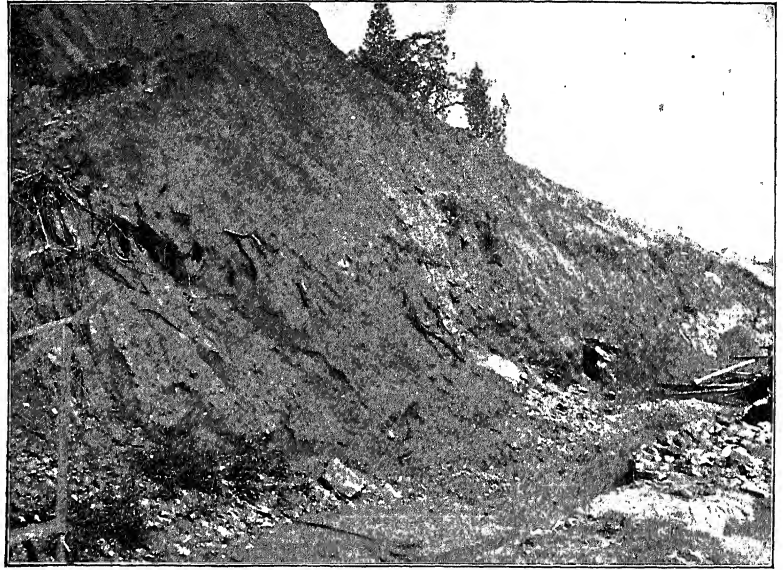
FIG. 85.—NEAR VIEW OF RIGHT SIDE OF BREAK IN EMBANKMENT OF LAKE FRANCES DAM SHOWING ROOTS EXPOSED BY THE BREAK.

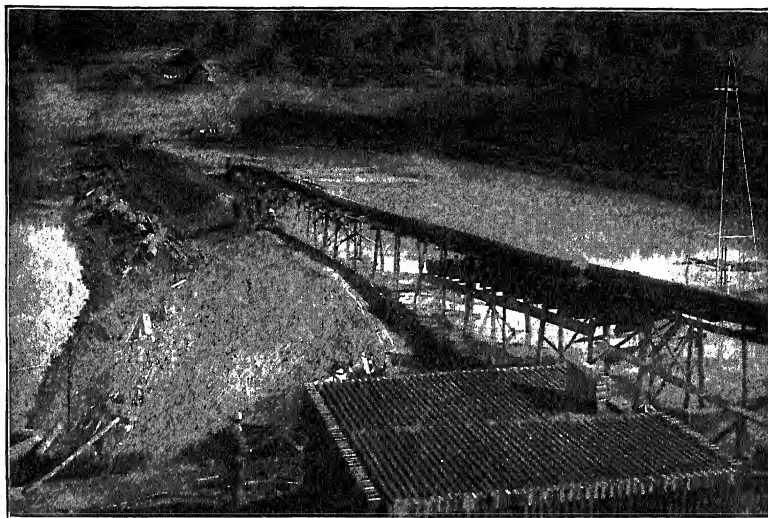
FIG. 86.—TOE LEVEE OF NORTH FACE, LAKE FRANCES DAM, AND INLET CRIB AT HEAD OF FIVE-FOOT OUTLET (CULVERT).

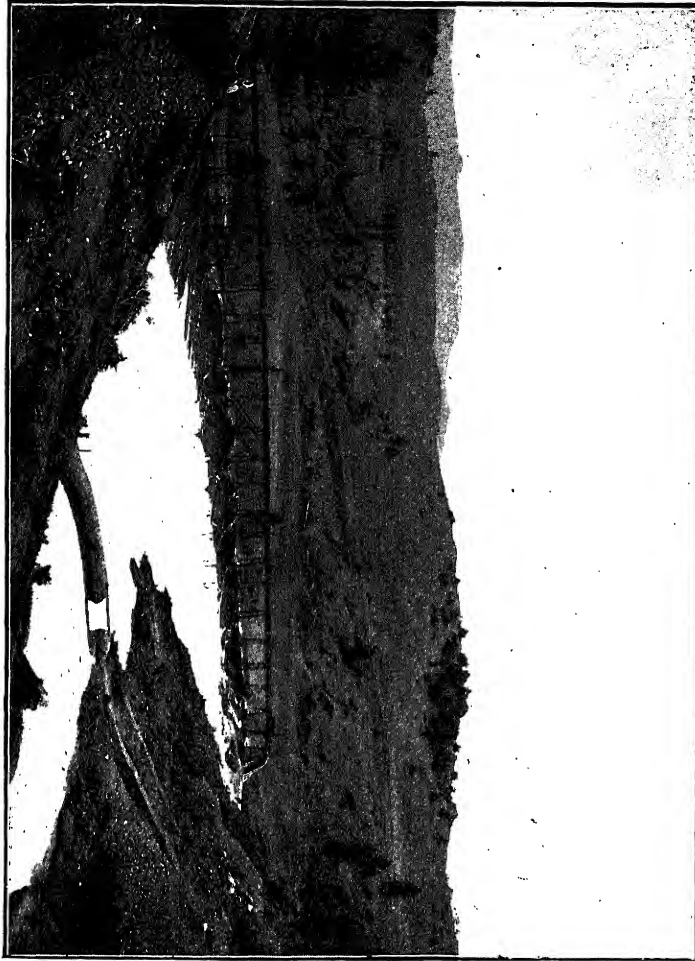
FIG. 102.—TERRACE DAM, COLO., SHOWING DEPOSIT OF SLICED MATERIAL ON UP-STREAM TOE OF DAM. THE ABANDONED CORE-WALL, 70 FEET HIGH, SHOWS JUST OUT OF WATER.

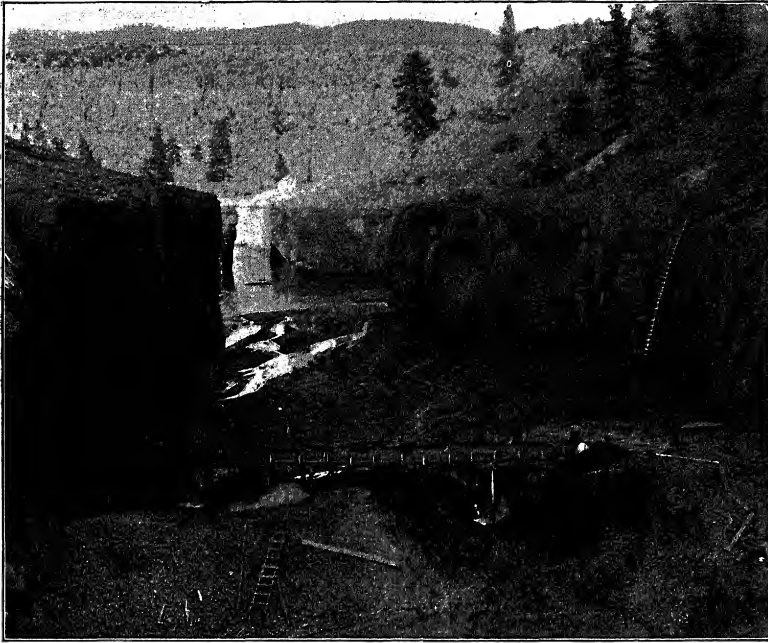
FIG. 104.—TERRACE DAM, COLORADO, LOOKING UP-STREAM. ILLUSTRATING GRADATION OF MATERIAL TOWARD THE CENTER OF THE DAM FROM THE POINT OF DEPOSIT AT THE SLOPES.

at the two slopes was clean rock and gravel of all sizes up to about 2 cubic feet, while in the center the puddle clay was of fine texture, leaving little to be desired as an impervious core, whose base measurement exceeds 500 feet up and down stream. The material was delivered to the dam through square flumes, lined with slabs and round poles to take the wear, and laid on a grade of 7%. The volume of water used was about 26 second-feet.

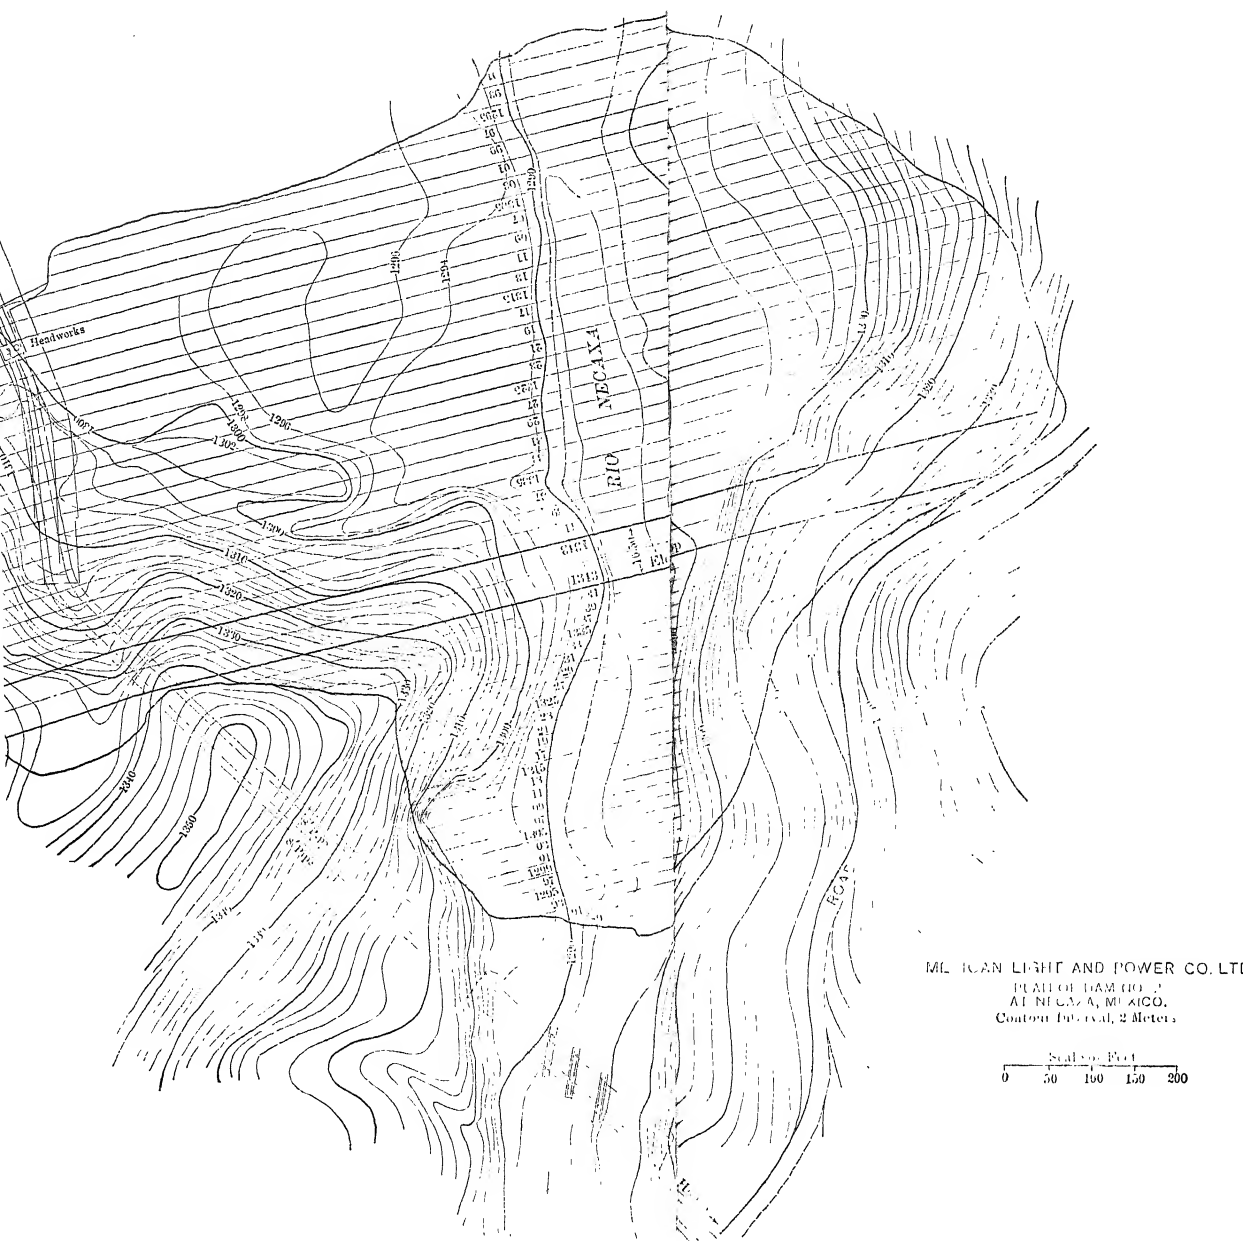
FIG. 113.

MEXICAN LIGHT AND POWER CO. LTD.
 PLANT OF DAM NO. 1
 AT NECAXA, MEXICO.
 Contour Interval, 2 Meters.

of the dams. The drawing, Fig. 113, illustrates the location of the dam and the general process of construction. Fig. 112 is an ideal section of the dam, showing the cut-off core-trenches, two on each side of the concrete core-wall.

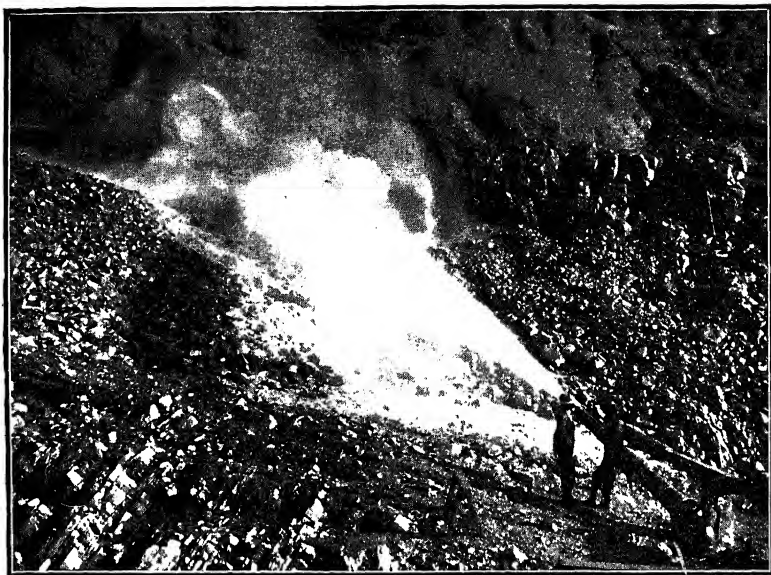
FIG. 117.—HYDRAULIC MONITOR WORKING ON LINE OF CONTACT BETWEEN LIMESTONE AND LAVA IN SPILLWAY CUT, NECAXA DAM, MEXICO.

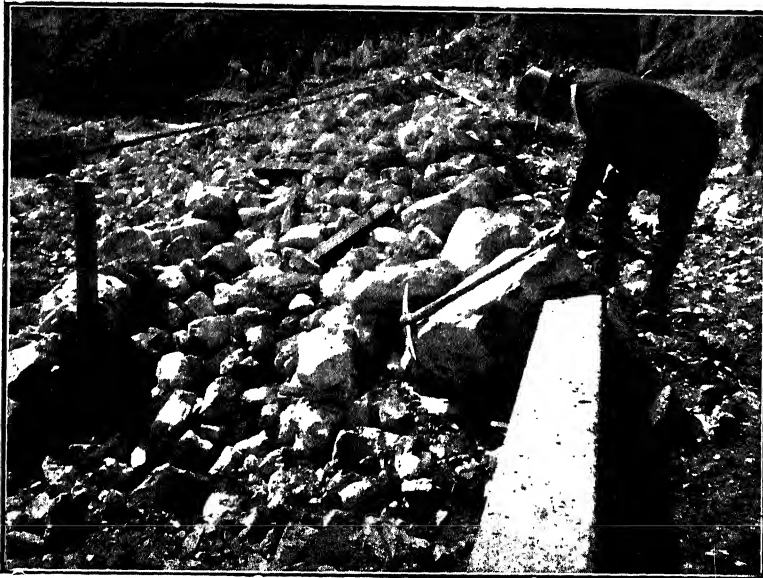
FIG. 119.—ILLUSTRATING THE SIZE OF STONE DELIVERED BY FLUME TO THE NECAXA DAM. THE LARGEST ONE MEASURED CONTAINED 18 CUBIC FEET.

of 60% to 70% mingled with stones of all sizes. The photographs, Figs. 118, 119, 120, 121, and 124 show the nature of the materials delivered to each and the manner of delivery.

A striking feature of this work, as illustrated by the photographs, Figs. 118 and 119, taken by the author in January, 1908, is the large size of rocks which have been transported through the flumes and deposited on the dam. Many of these contain upwards of 15 cubic feet and weigh over 1 ton. In this respect the magnitude of the operation exceeds any hydraulic sluicing ever before attempted. The down-stream slope is being covered with 2 feet of masonry laid in Portland cement, using

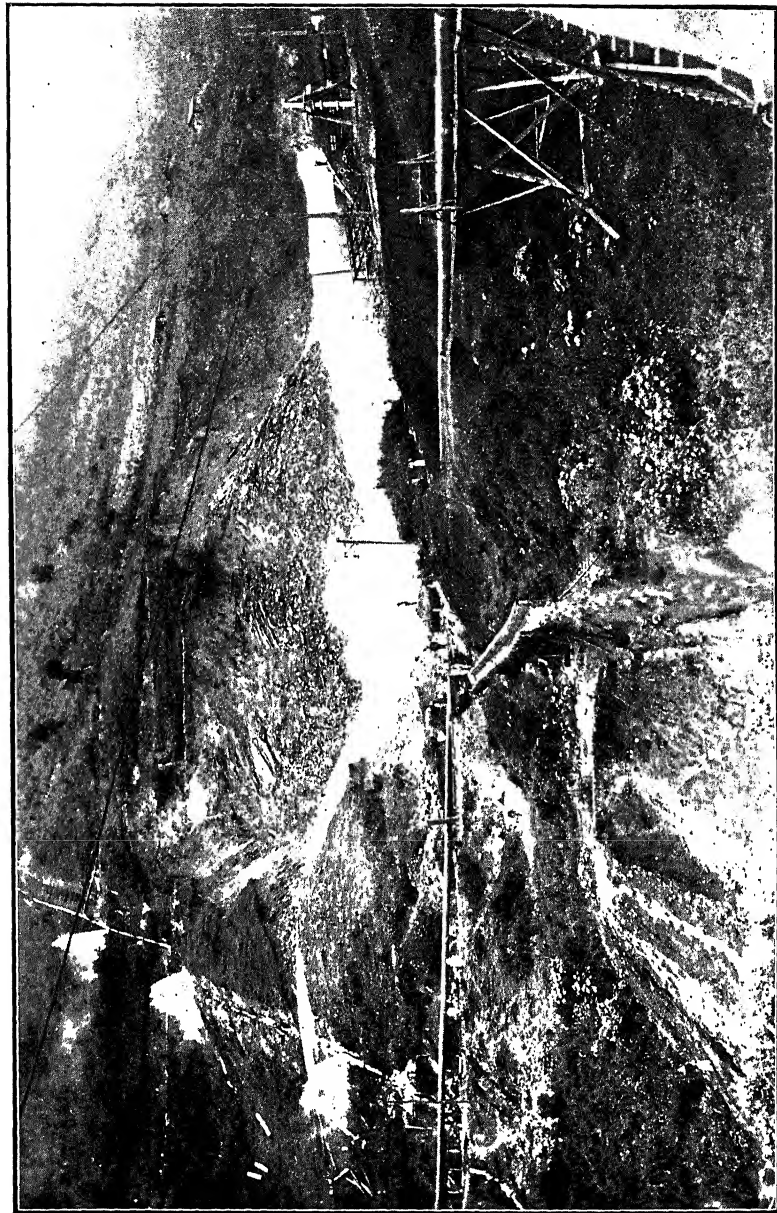
FIG. 127.—HYDRAULIC SLUICING AT NECANA, JUNE, 1907. SHOWING TILTED LIMESTONE LEDGES IN PIT No. 1,
OVERLAID BY CLAY AND LOOSE ROCK. 164

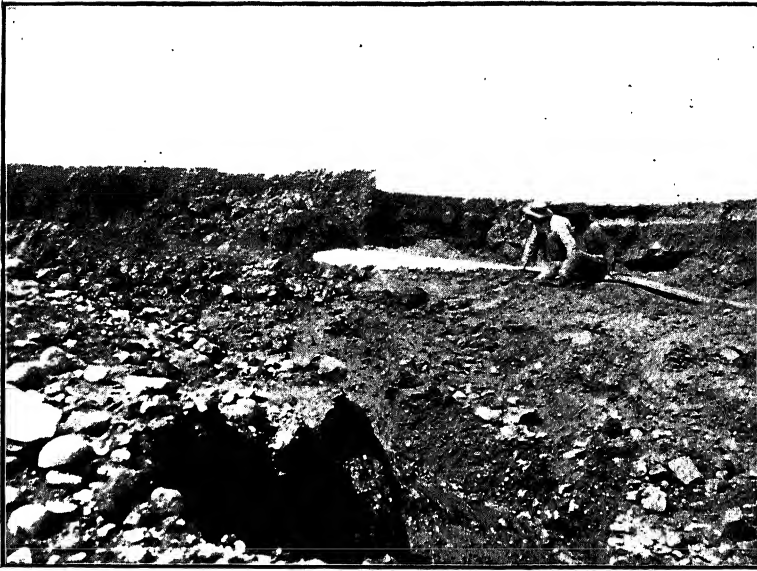
FIG. 134.—YORBA DAM, CALIFORNIA. HYDRAULICKING AN EARTH BANK WITH WATER PUMPED THROUGH 1-INCH NOZZLE UNDER 25 POUNDS PRESSURE.

Fig. 134 shows the operation of hydraulic sluicing, and Fig. 135 illustrates the method of delivery of earth upon the dam. The surplus water was drained from the pond through stand-pipes built up in successive layers and connecting with the main outlet-pipe through which the water was fed into the reservoir. The entire cost of the dam was about \$38,000.

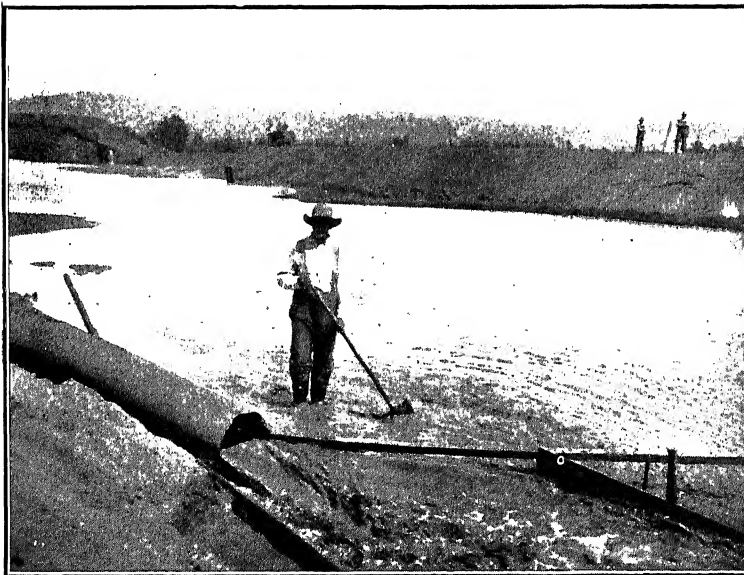
FIG. 135.—YORBA DAM, CALIFORNIA. SHOWING DISCHARGE OF PUMPED MATERIAL, ALONG UP-STREAM TOE LEVEE.

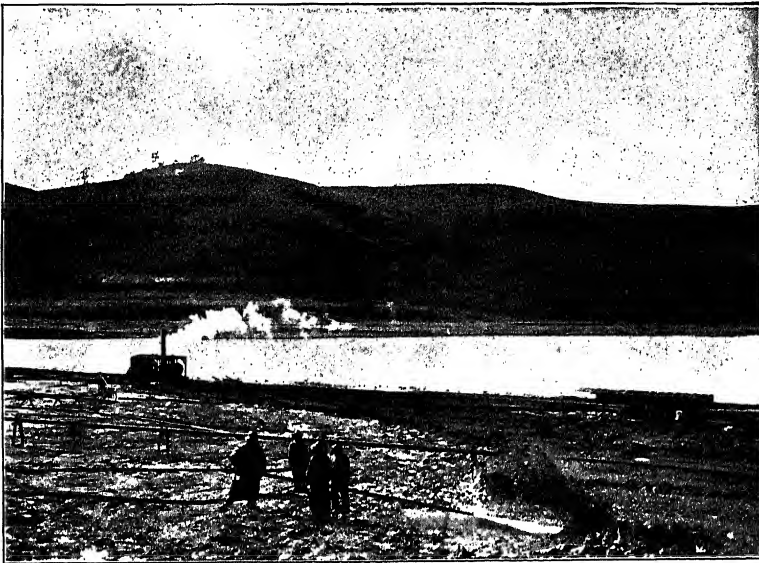
FIG. 136.—SILVER LAKE DAM, LOS ANGELES. THE EARTH, LOOSENED BY THE HYDRAULIC JET, IS CONVEYED TO THE PUMPING STATION SHOWN AND PUMPED TO THE DAM.

At the lower levels the material used to build the dam was loosened and dissolved by ground sluicing with water taken from a grade-line pipe passing through the reservoir. The liquefied earth flowed by gravity down the slope to a sump whence a centrifugal pump forced it through a pipe to the dam, where it was distributed by flumes and lateral branch pipes. At a later stage the hydraulic jet was used for loosening the earth, the water being pumped by a single-stage centrifugal pump through 4-inch pipe, and delivered under pressure of 70 to 100 pounds through 2-inch nozzles, controlled by a local modification of the more expensive hydraulic monitor used in the mines.

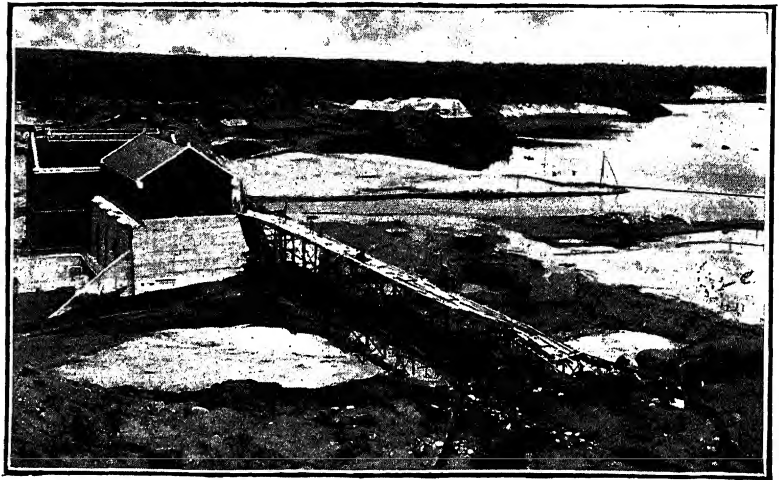
FIG. 137.—CROTON HYDRAULIC-FILL DAM, MICHIGAN, DURING CONSTRUCTION.

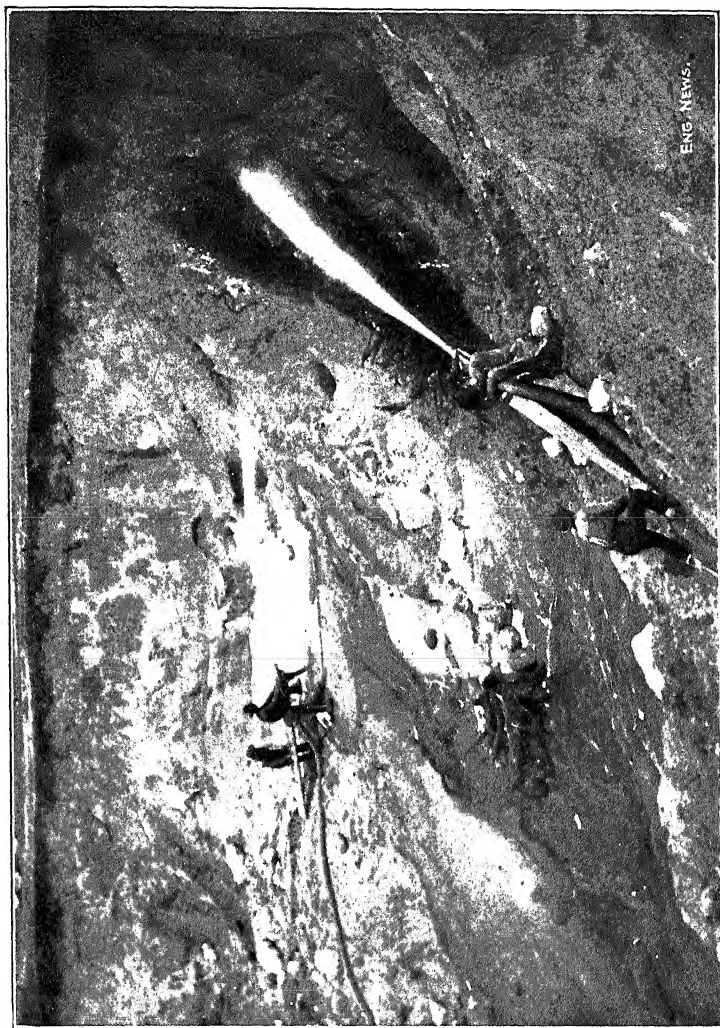
FIG. 139.—HYDRAULIC SLUICING ON THE CROTON DAM, SHOWING THE IMPROVISED NOZZLE CONTROL,
OR HYDRAULIC MONITOR.

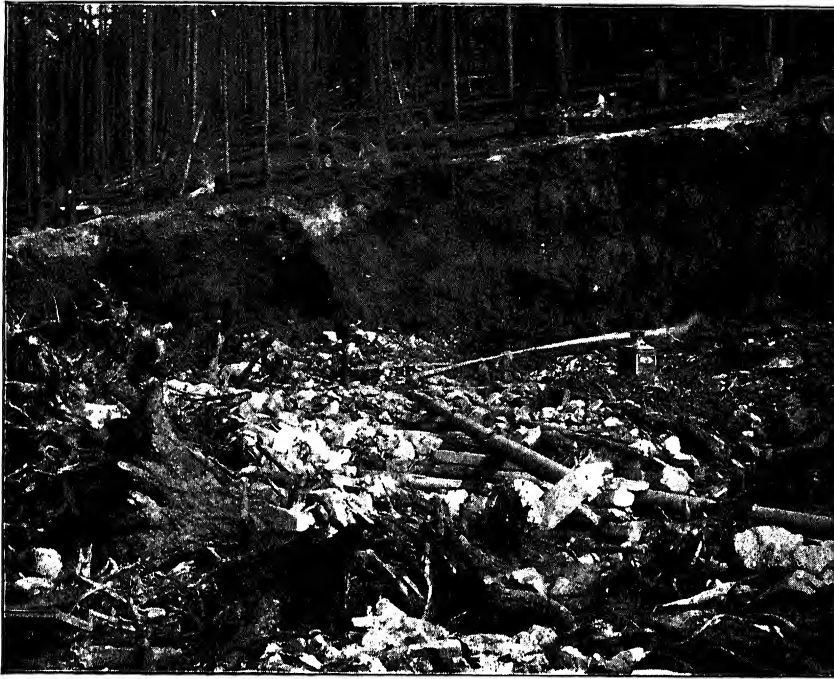
FIG. 145.—NORTHERN PACIFIC RAILWAY, HYDRAULIC-FILL CONSTRUCTION. VIEW IN PIT SHOWING HYDRAULIC GIANT IN ACTION.

By courtesy of E. H. McHenry, Chief Engineer, and Charles S. Bihler, Division Engineer, Northern Pacific Railway, the writer has been furnished with the interesting photographs of the work (Figs. 143, 144, 145, and 146), which illustrate the process of hydraulic filling very clearly in all its phases, and demonstrate with what precision embankments can thus be

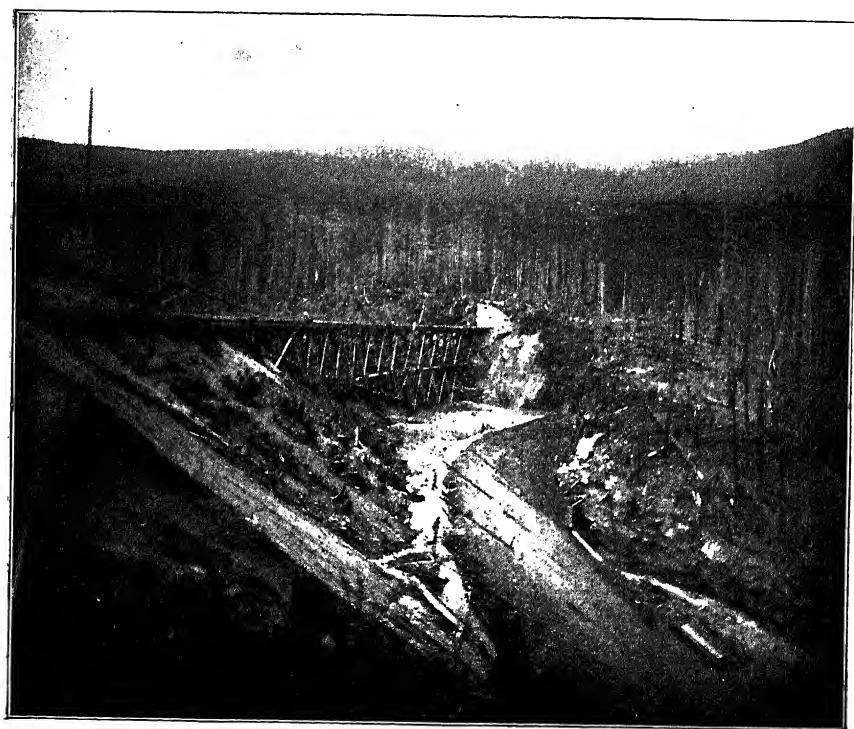
FIG. 146.—NORTHERN PACIFIC RAILWAY, BRIDGE 184. HYDRAULIC FILLING IN PROGRESS.

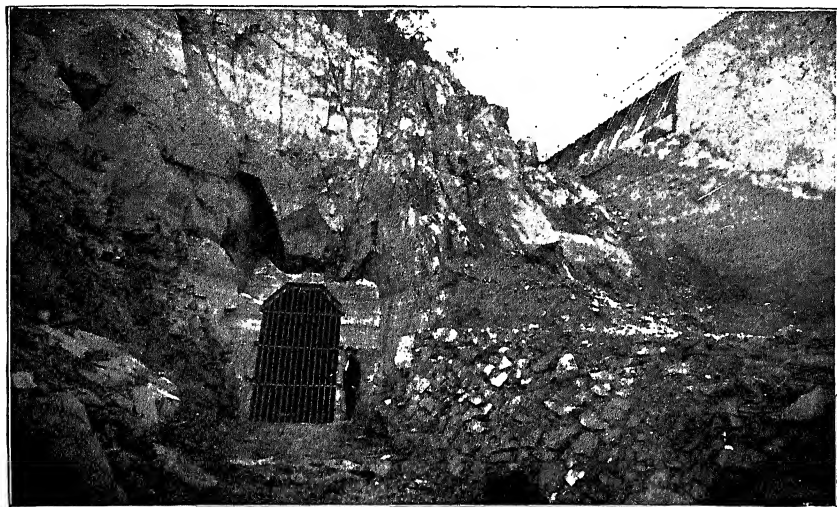
FIG. 163.—SWEETWATER DAM, SHOWING HEAD OF OUTLET TUNNEL AND SPILLWAY.

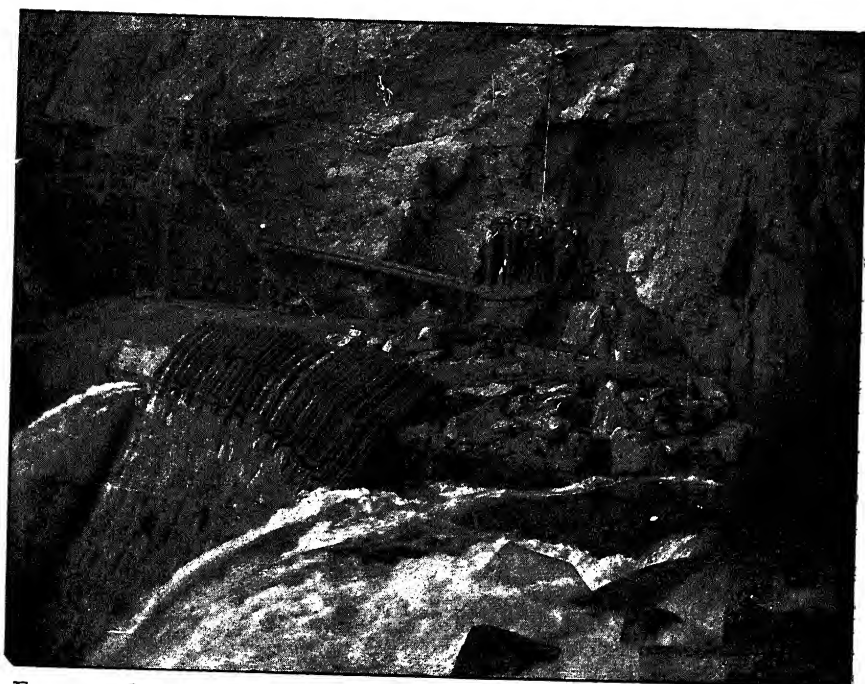
FIG. 181.—LA GRANGE DAM, CALIFORNIA, DURING CONSTRUCTION—FINISHING THE CREST.

The Modesto district covers 81,500 acres, with a main canal 22.75 miles long before reaching the district, having a capacity of 640 second-feet. The entire irrigation system when fully completed will be the largest and most comprehensive one in California, and the dam upon which its success depends has been wisely constructed of such dimensions as to be of unquestionable stability. Figs. 180 to 185 are views of the structure.

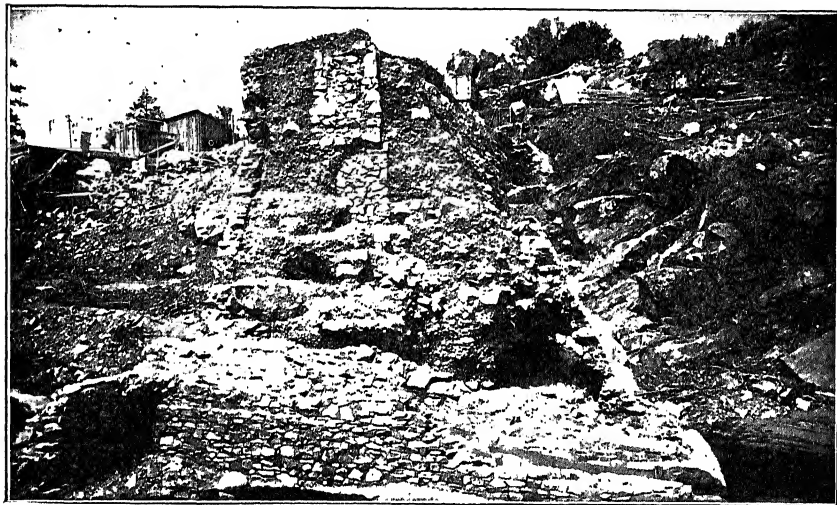
FIG. 210 —LYNX CREEK DAM, ARIZONA. SECTION SHOWING FACING WALLS AND CONCRETE HEARTING.

floods draining the tributary watershed of 30 square miles of territory, from 5500 to 7500 feet in elevation, had the masonry been of reasonably good quality. The failure, therefore, was clearly due to poor workmanship and unsuitable materials. The dam was 150 feet long on crest, and was built with a central angle of about 165° opposed to the direction of the current, the up-stream face being vertical. The wall consisted of a thin facing of hand-laid masonry, not over one foot thick, the core being filled with a weak concrete of fine gravel, stone, spawls, and sand. The section of the dam as constructed is clearly seen from the photograph (Fig. 210). Considerable lime was used with the cement, which was of poor quality, and the concrete, though ten years old, possesses so little cohesion that it may be crumbled with a light touch. The cement used averaged but 1 barrel to 6 cubic yards of masonry. The failure of the dam, under all the circumstances, might have been anticipated. It is referred to here merely as an example to illustrate the natural consequences that must follow any carelessness or lack of attention to proper selection of materials and skill of construction in masonry or concrete dams that must withstand the erosive action of floods as well as normal water-pressure.

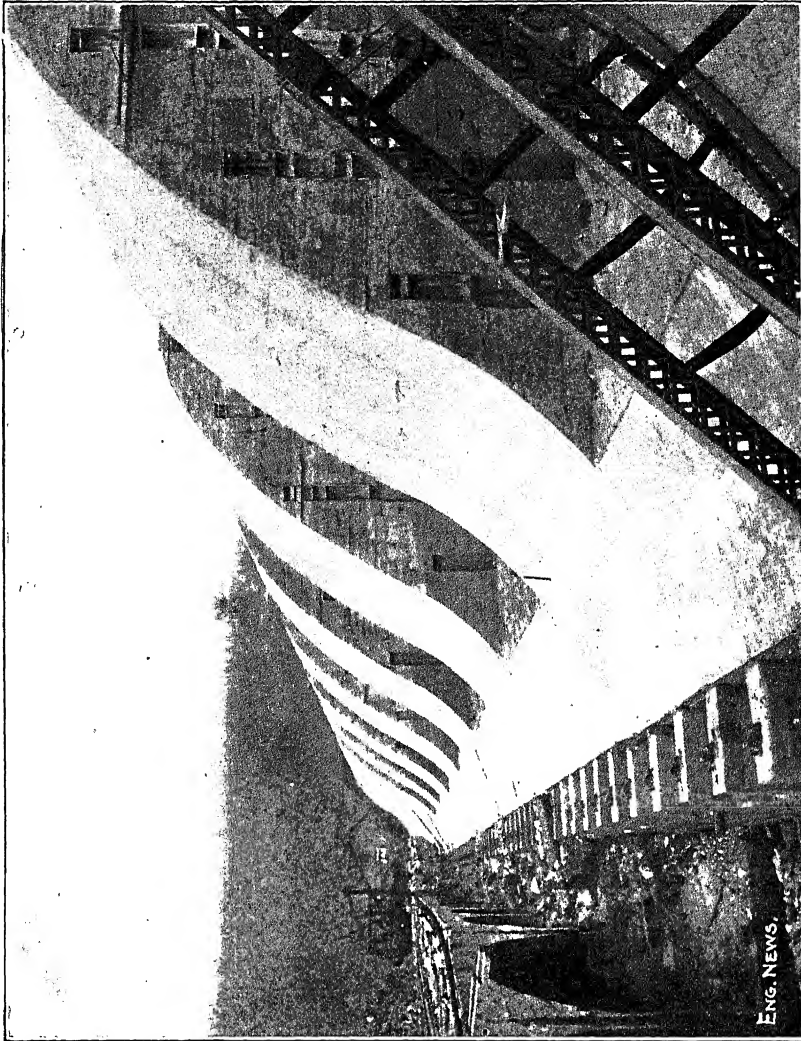
FIG. 241.—McCALLS FERRY DAM, PENNSYLVANIA.

miles west of Philadelphia, by the erection of a masonry dam, 55 feet maximum height, 2350 feet in length, with a base width of 65 feet. The dam is of ogee form, and is to be used as an overflow for its entire length. The dam when completed will contain 330,000 cubic yards of concrete, including that in the power house and the construction bridge.

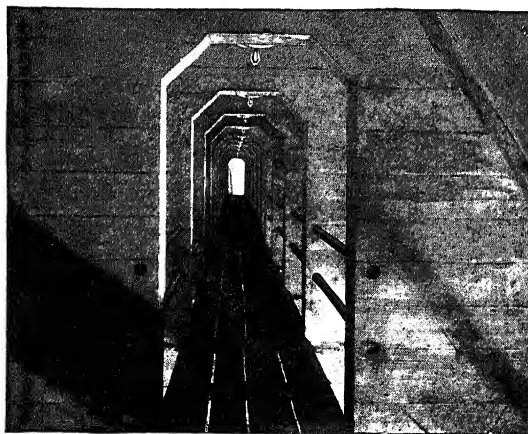
FIG. 309.

river to the other, as a substitute for a foot-bridge over the stream. Such a passage is illustrated in Fig. 309.

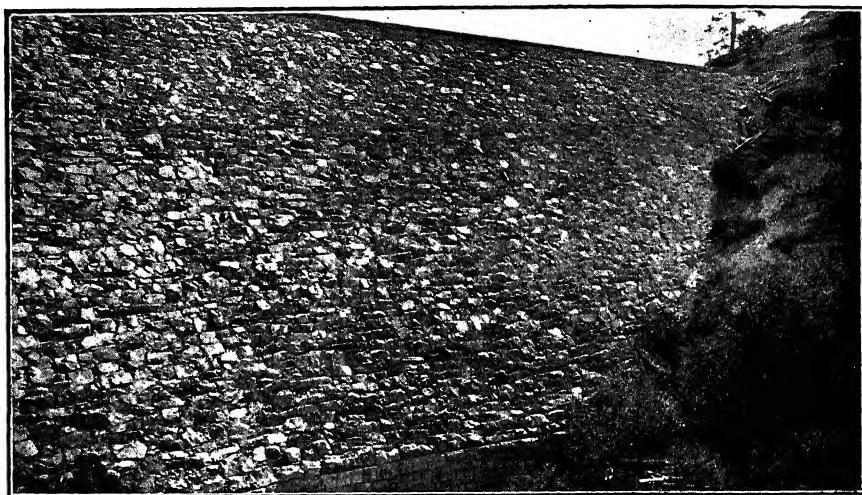
FIG. 338.—DOWN-STREAM FACE OF BOWMAN LAKE DAM, CALIFORNIA, ILLUSTRATING THE QUALITY OF THE DRY MASONRY.

The Bowman Rock-fill Dam.—Renewed interest is being taken in the old rock-fill dams of the Sierra Nevada Mountains, in Northern California, built originally to store water for hydraulic mining, because they are becoming valuable for the double uses of generating power and affording domestic and irrigation supply to the valley below. The Bowman dam, described on page 65, and outlined by cross-sections, Fig. 44, is more clearly illustrated in its situation and construction by Figs. 336, 337, 338, 339, and 340.
